## FIVE X FIVE SERIES (projects smaller than 25 sq.m.)

### North-facing Patio: Southampton, Hampshire completed Spring 2009

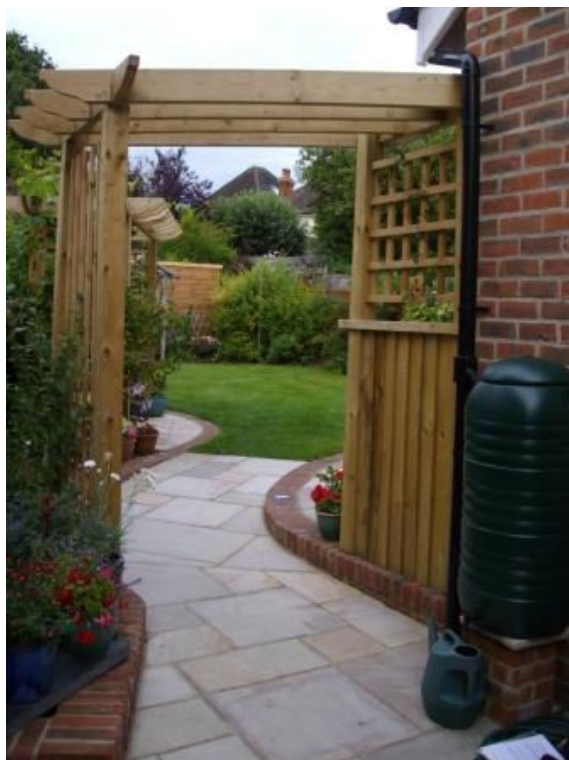
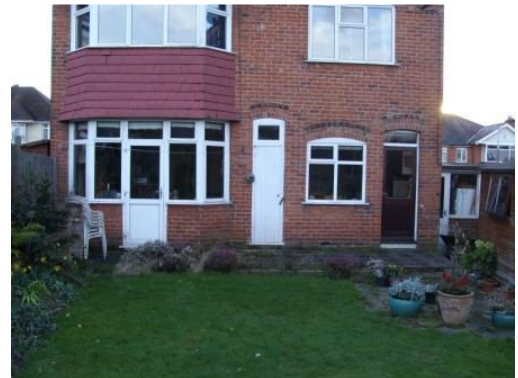
^ **BEFORE:** the small patio area at the rear of this detached property will be partially built over during the house extension works. The side access to the rear garden is very narrow. v **AFTER:** the lawn is now flush with the larger patio area, creating a seamless transition from the house to the garden

A 1.2m deep wooden stub wall and pergola was built on to the NW corner of the property to deflect the wind. Another long brick wall with built-in barbecue / outdoor kitchen area was extended from the opposite corner of the property to create a contained, balanced space framing a 4m deep patio.

The next task was to link smoothly from the patio area and rear garden around the narrow side access without creating pinch points or drawing attention to the awkward boundary area. My clients opted for a sinuous, gently curving pathway that bisected the patio area and sloped down gradually towards the lower surface area at the side of the property. This then created a second, smaller seating area under a pergola sited to train the existing vine over, and overlooking the main patio area.

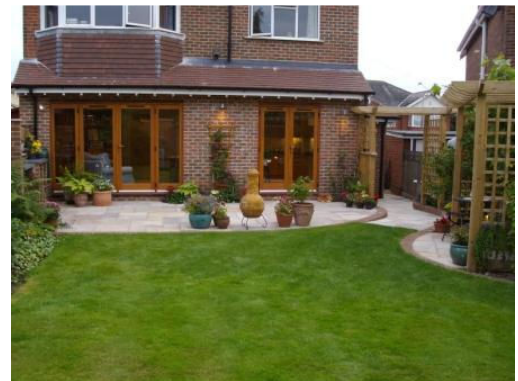
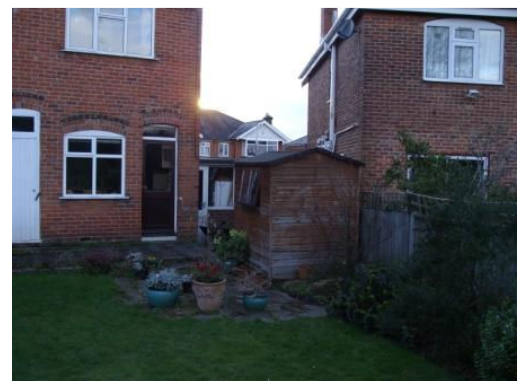
^ **BEFORE:** the cluttered side access area with the changes in surface level visible v **AFTER:** the path towards the side of the house now slopes down gently along the edge of the main patio. Trellis work adds valuable privacy along the western boundary. A new shed is located further down the garden
